Southeastern Anglers Association Inc.

Subject: Mill Creek – 2017 Summary of Instream Work Completed by Southeastern Anglers Association

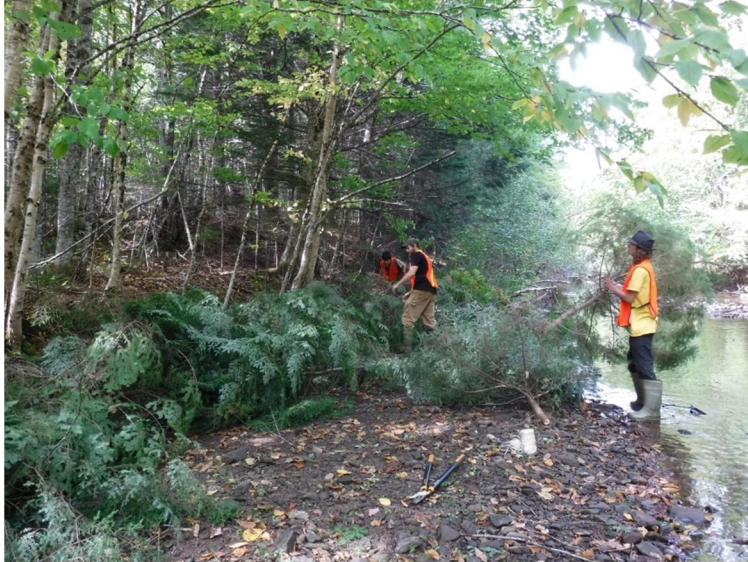
On September 28, 2017 the SAA installed 35m of brush mattress along an eroded bank located on the inside bend of Mill Creek. A failed digger log, located upstream from the site, resulted in bank erosion, loss of floodplain habitat, and an over-widened channel. The installation of the brush mattress was completed with use of hand-tools and manual labor only, no machinery was used. No disturbance to the streambed or bank occurred during installation. Brush material was sourced approximately 100m away from top of bank. When possible, damaged or dead trees/branches were used and were collected from multiple areas to minimize the concentration of disturbance. Brush materials were anchored to existing stumps/trees with biodegradable twine. The brush mattress treatment covered an area of approximately 140m² (35m length x 4m width). Brush mattress was installed at UTM Zone 20T E 359499 N 5145620.

Figure 3 showing SAA field staff installing the brush mattress, viewing upstream.

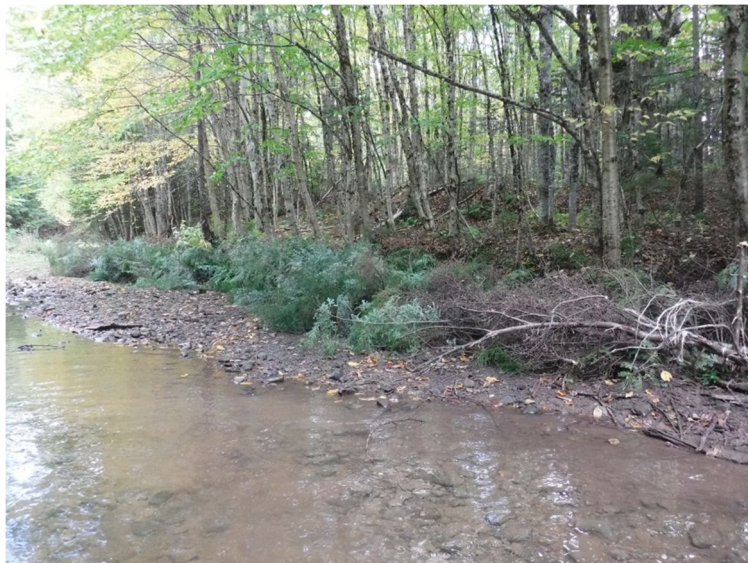
Figure 4 Showing completed brush mattress located on inside bend of meander, viewing downstream.
