# Restoration in Mill Creek

**Association des pêcheurs récréatifs du sud-est (APRSE)/  
Southeastern Anglers Association (SAA)**

**Cocagne, New Brunswick  
Report 2017-2018**

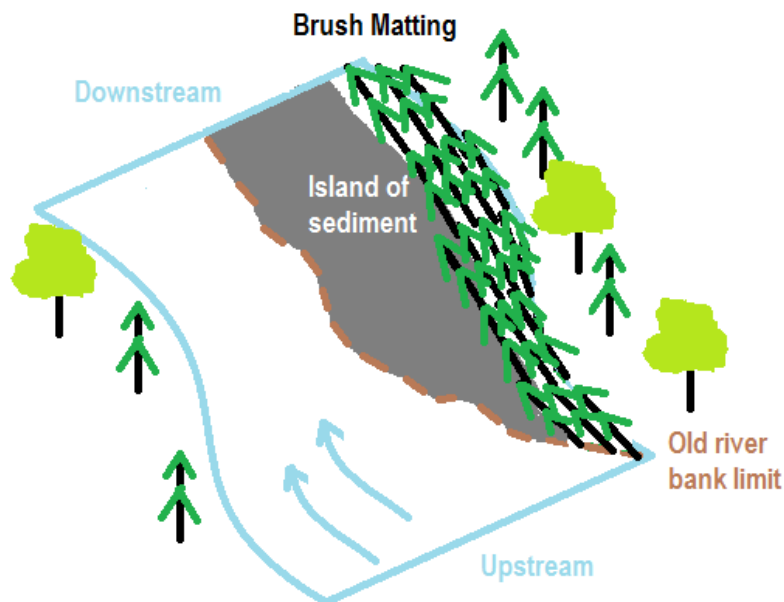
The 'brush matting' technique is an overlay of several small coniferous trees overlapped on each other and secured to the riverbank (see figure 1). It was secure as best as possible with stakes and rope attached to riverbank trees. Before and after pictures of the site are annexed to this report (along with site coordinates) and some are also in Matrix Solutions' report. Furthermore, Matrix Solutions' report contains details on the structure's location and why it was created. Results from the geomorphic and habitat survey have also been annexed.

Figure 1: Brush matting technique to accumulate sediments in areas where it was lost.

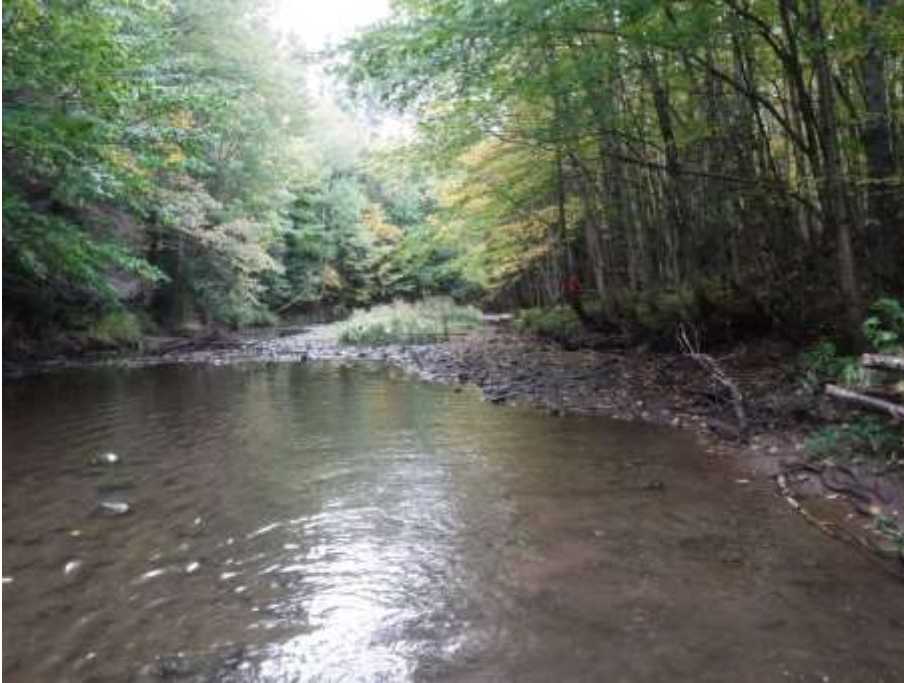
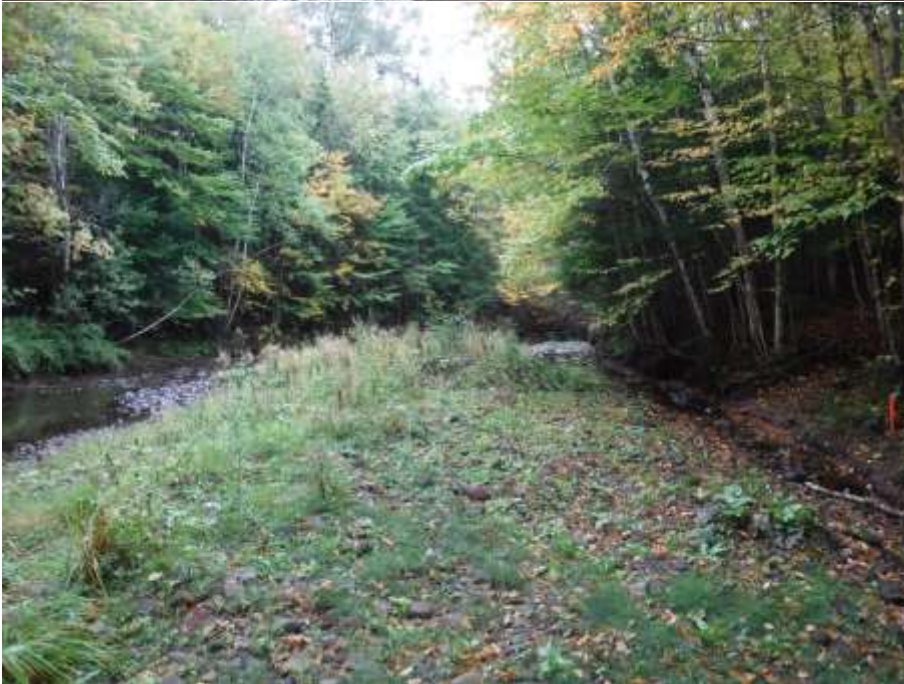
N 46,26,59.3747 W 064,49,46.6069  
Site 3 was chosen to build brush matting:

Before pictures:  
Looking downstream of the site

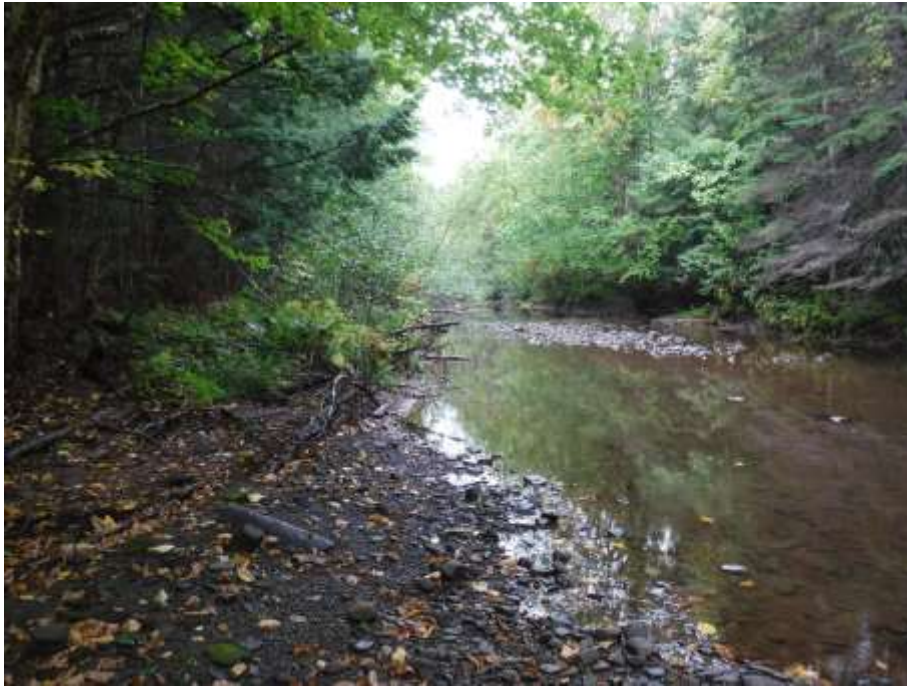
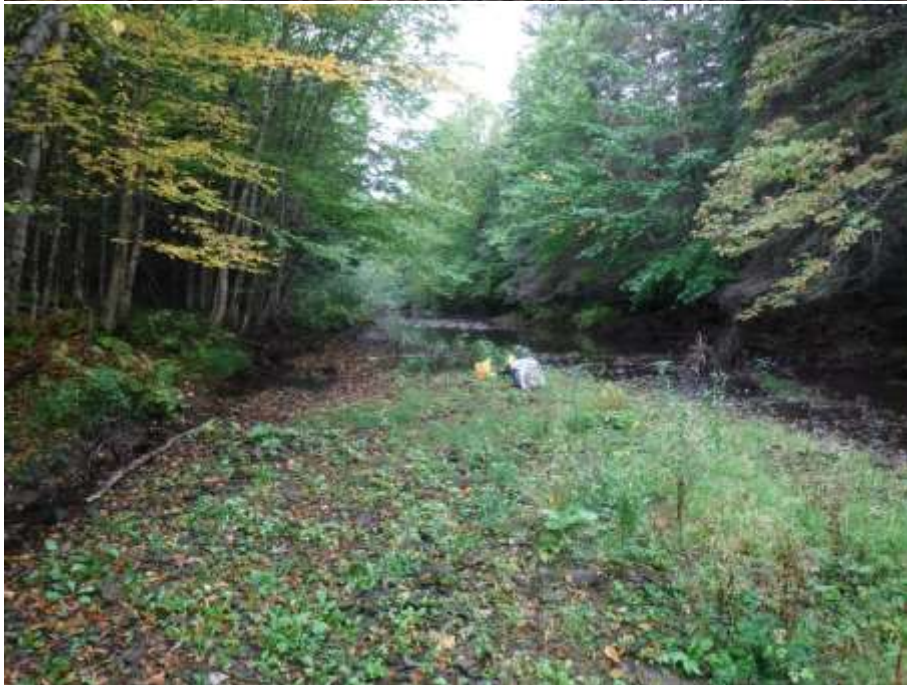
Looking upstream of the site

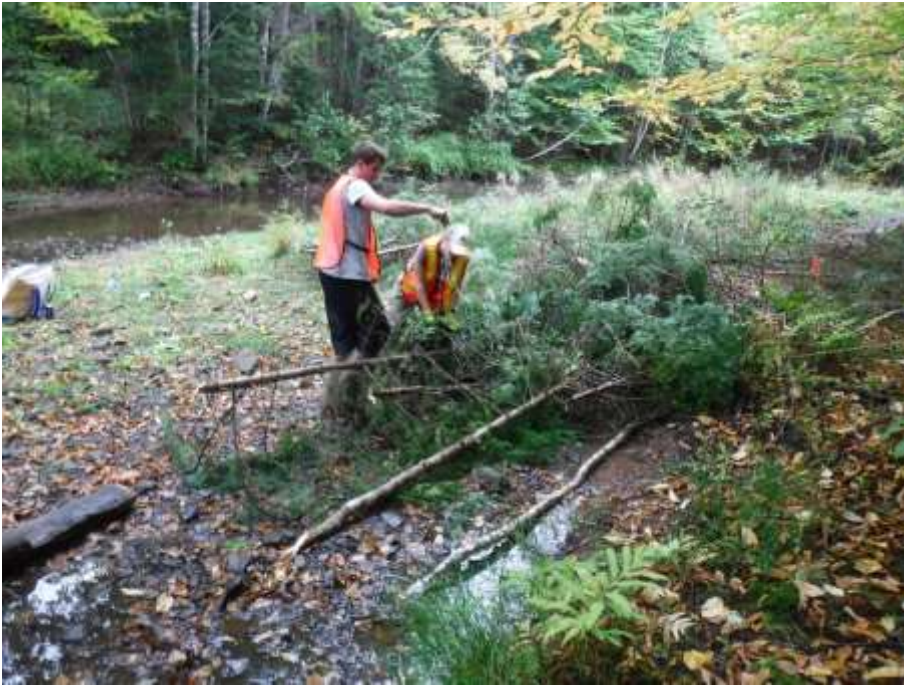
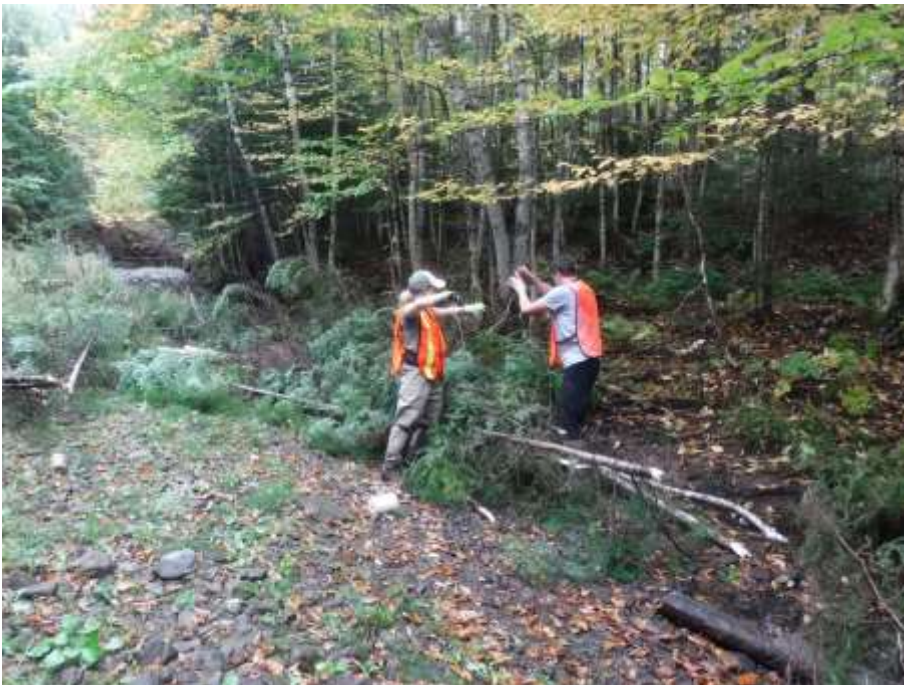
Looking downstream of the site – building the brush matting

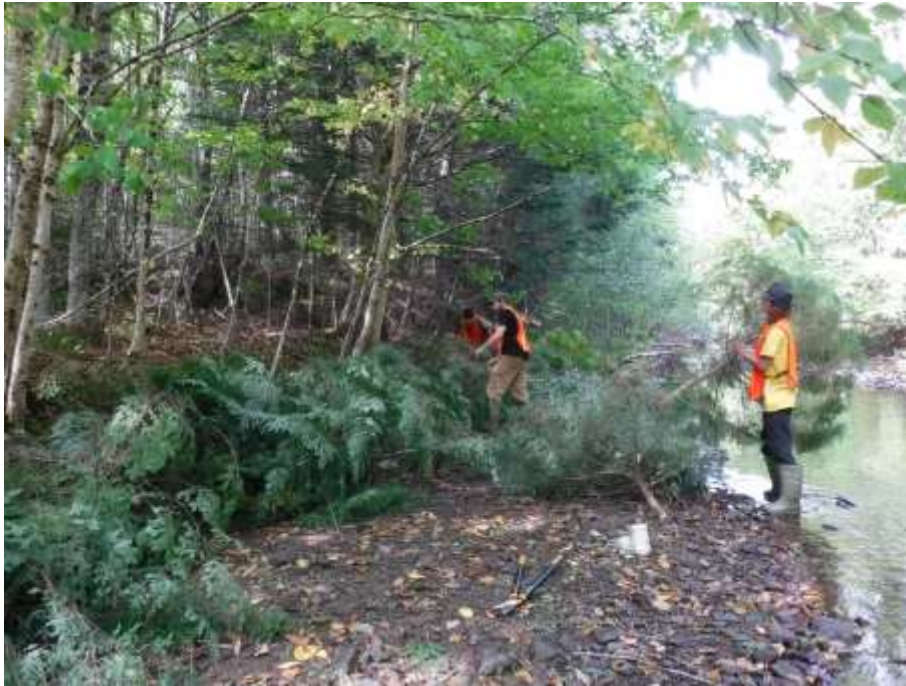
Looking upstream of the site – building the brush matting

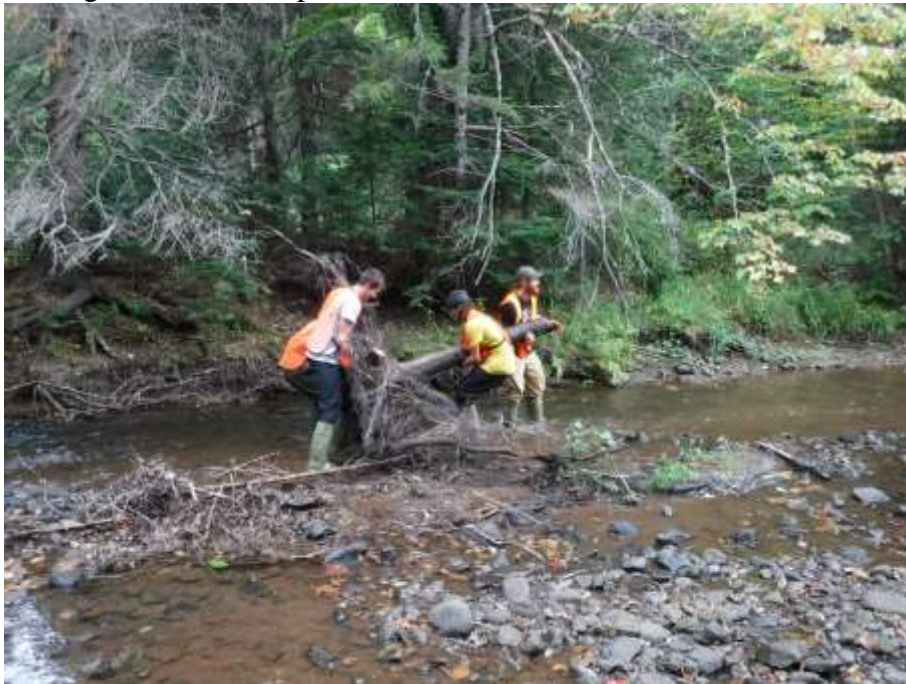
Getting out a tree stump in the river channel

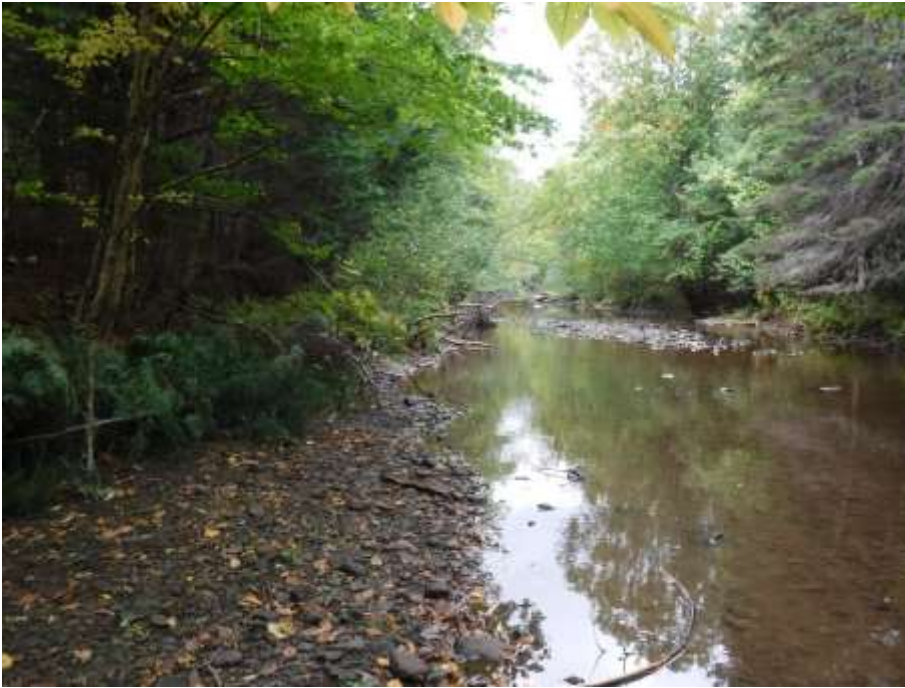
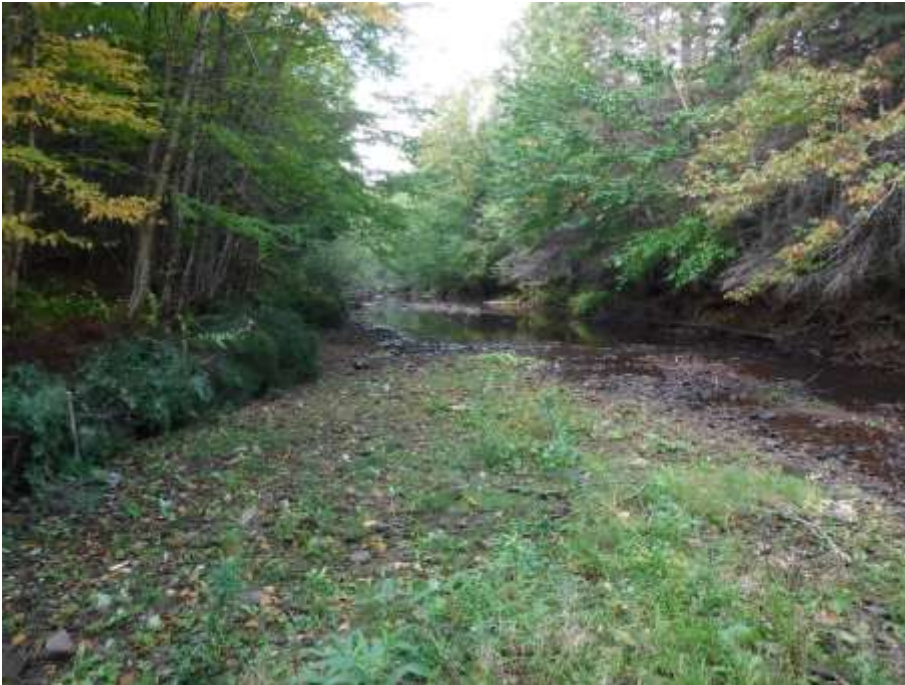
After pictures:  
Looking upstream of the site

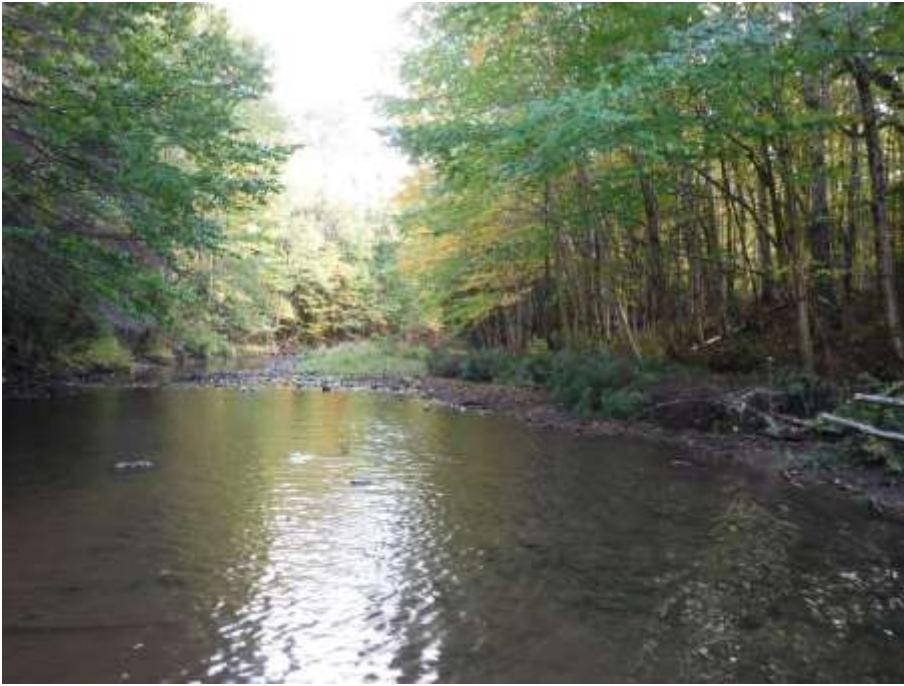
Looking downstream of the site

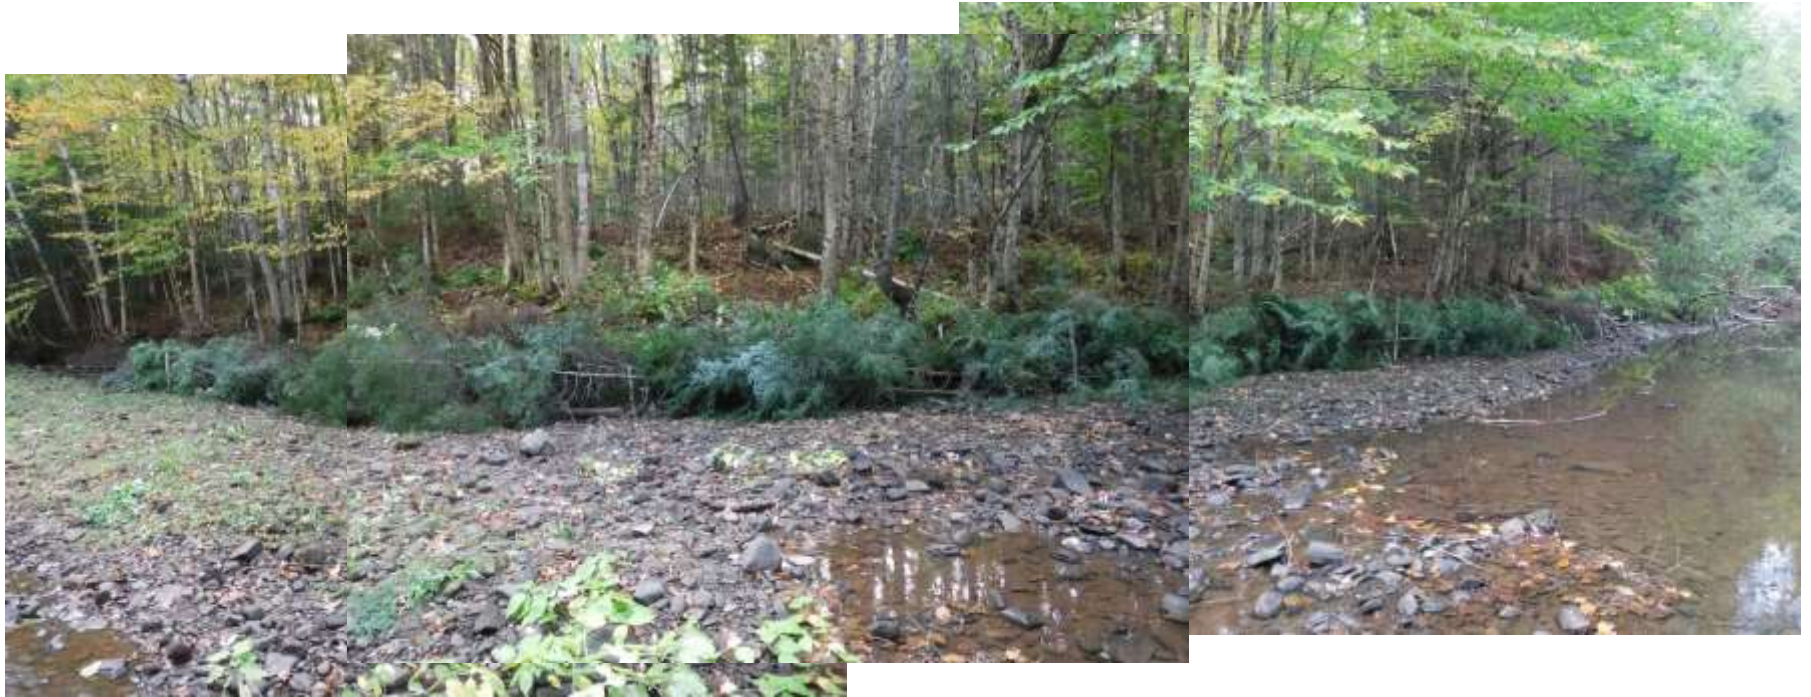
The side view of the brush matting (approximately 140m<sup>2</sup>; 35m length x 4m width):

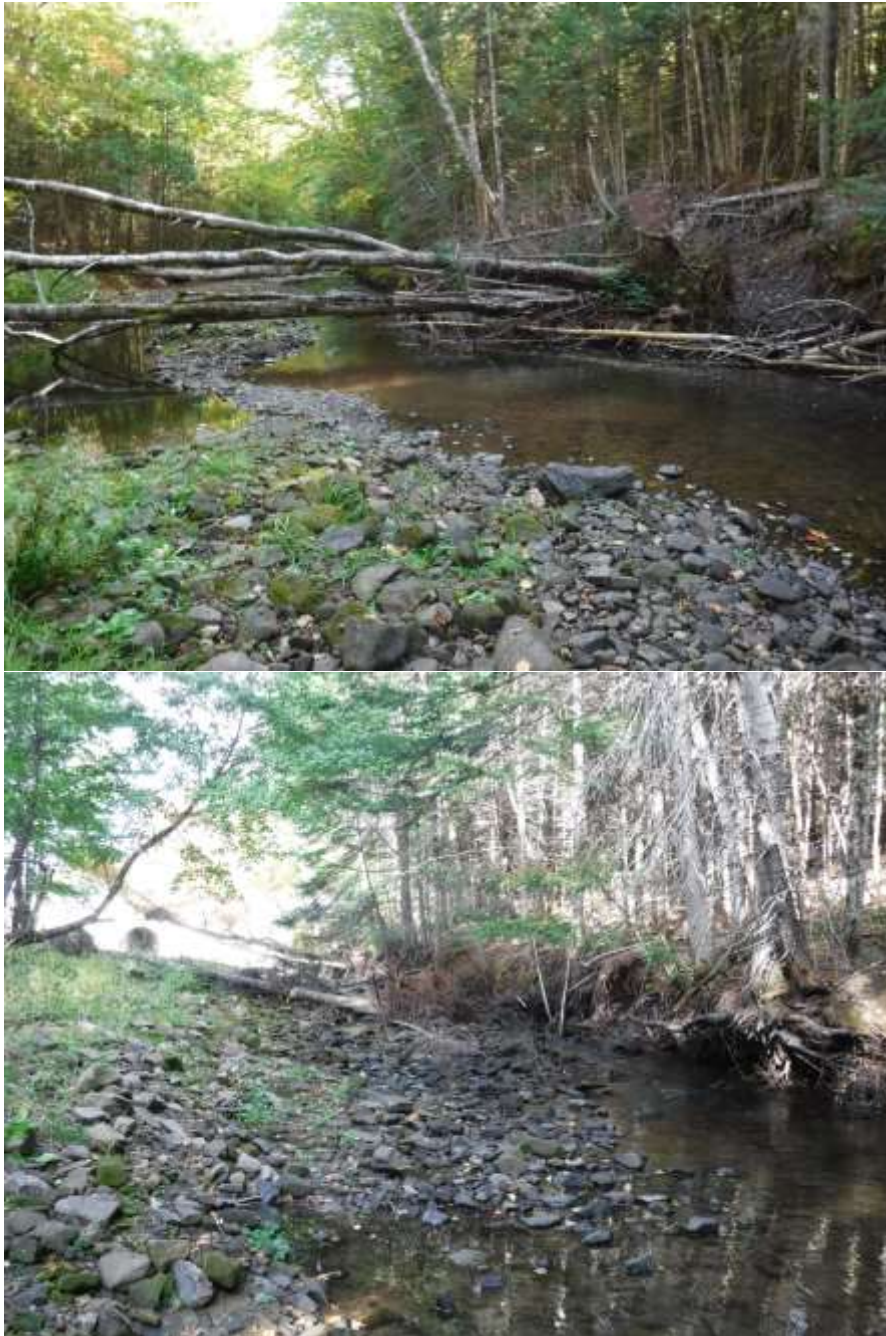
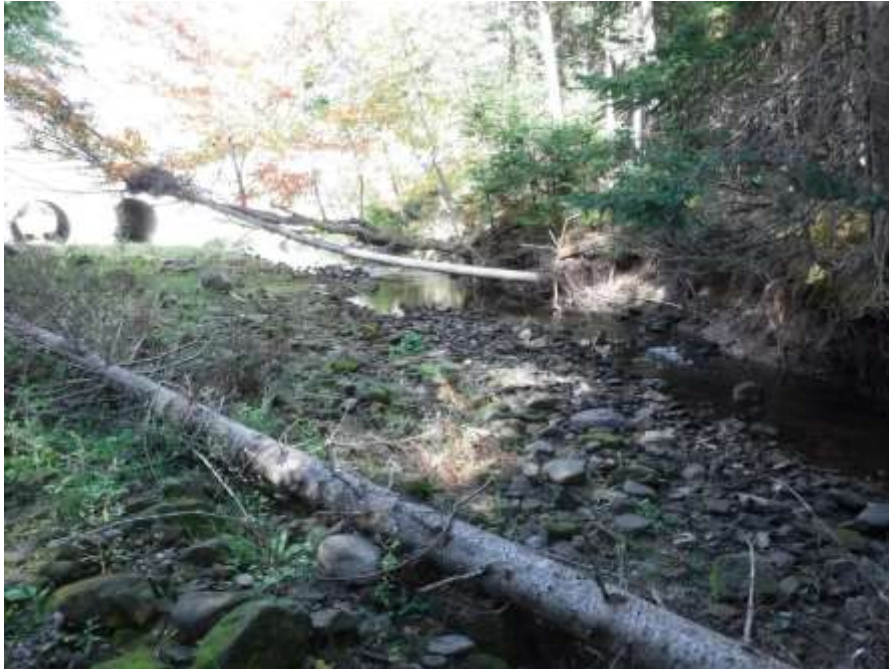
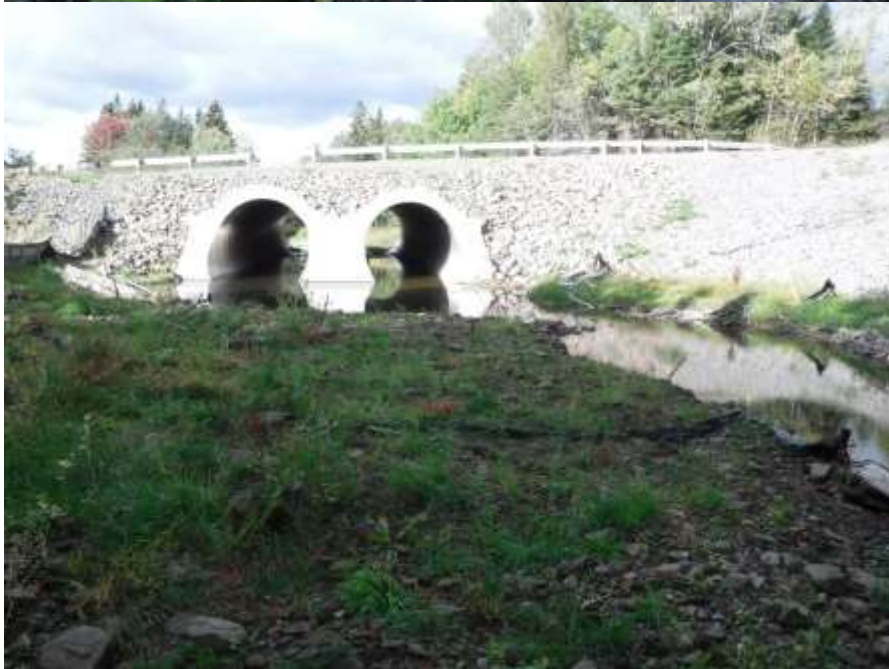
Near the culverts

The re-evaluation of Mill Creek has shown that more damaged had been added to this watercourse due in part by the new culvert installed. Some of these changes involved increasing riverbank erosion, un-rooting trees, and uncovering the riverbed by exposing more bed rock.

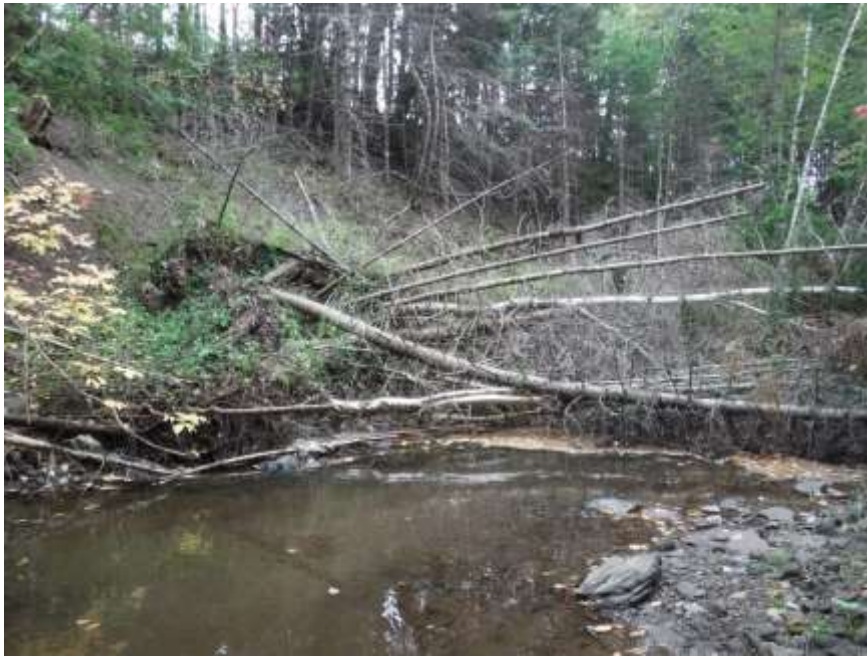
Near site 3 (approximately 50m downstream of brush mat)

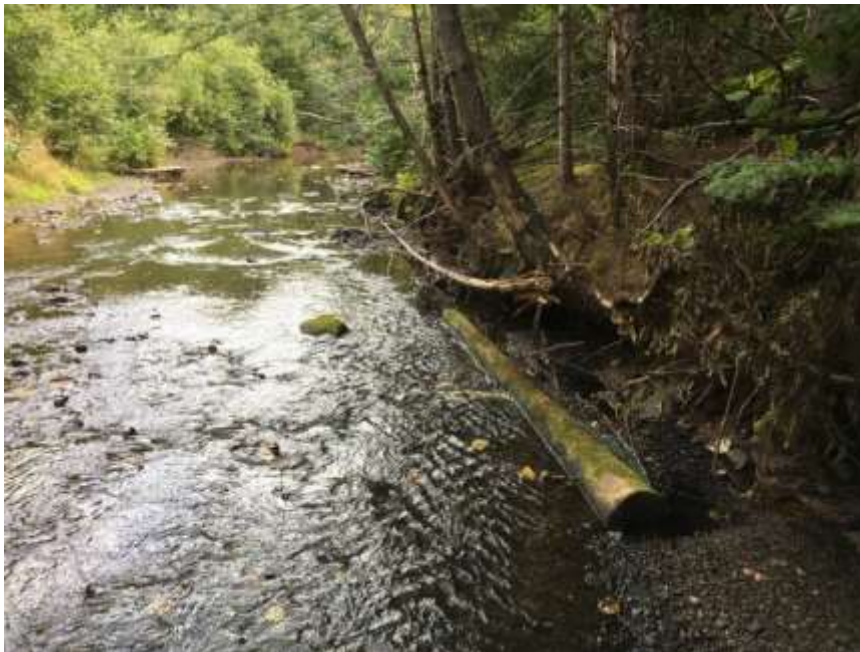
Site 6: After

Some netting that was attached to the log was removed but the log has been left in place.
