Report Prepared for: SOUTHEASTERN ANGLERS ASSOCIATION

Prepared by: PARISH AQUATIC SERVICES

February 2017 Fredericton, New Brunswick

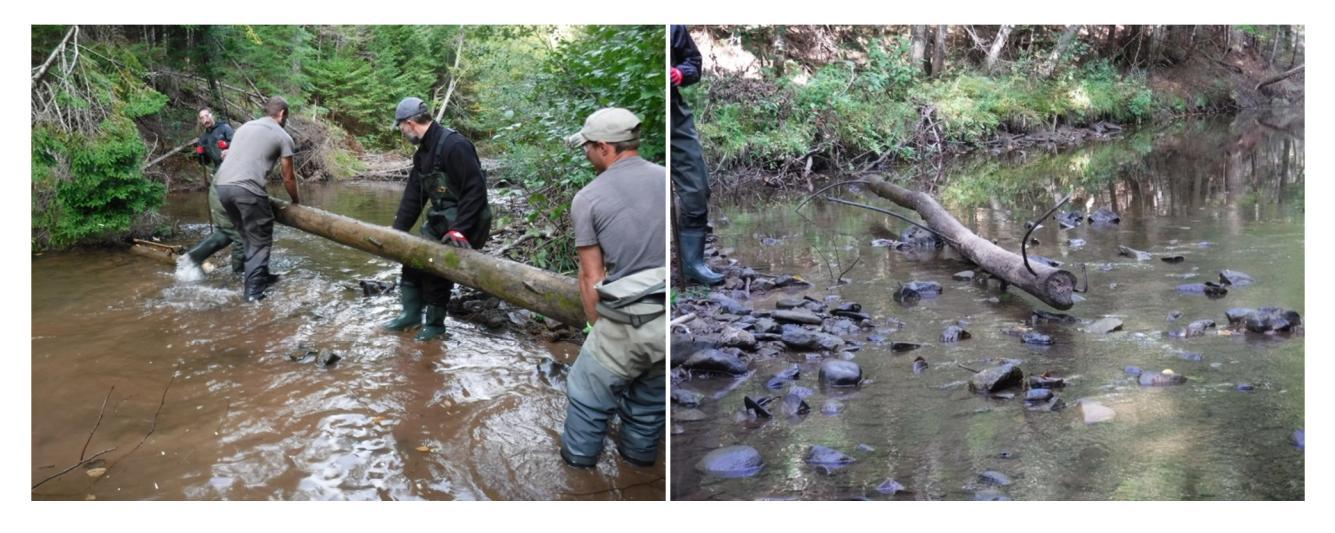
The digger log was anchored to the bed with metal re-bar and nylon netting. The banks were eroded at both ends of the structure. If not removed, further bank erosion and channel widening would have resulted.

Structure being removed. Banks were eroded around ends of structure.

Digger log after removal. Note metal re-bar anchors.

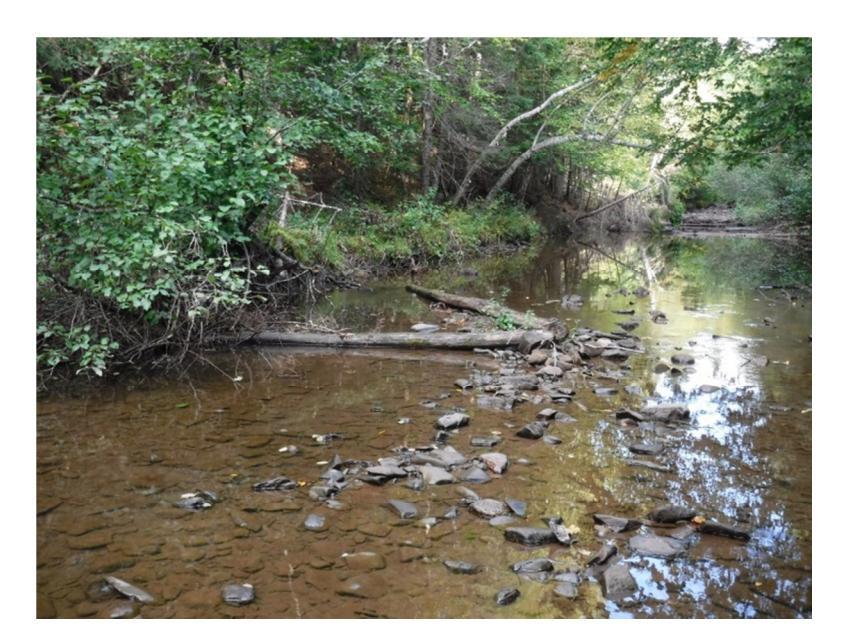
The wing deflector was located on the right bank. Banks were eroded around both ends of the structure and it was not tied into the bank. If left intact, it would have continued to cause degradation (bank erosion, channel widening and sedimentation to downstream areas).

Log wing deflector, anchored with re-bar and nylon netting.

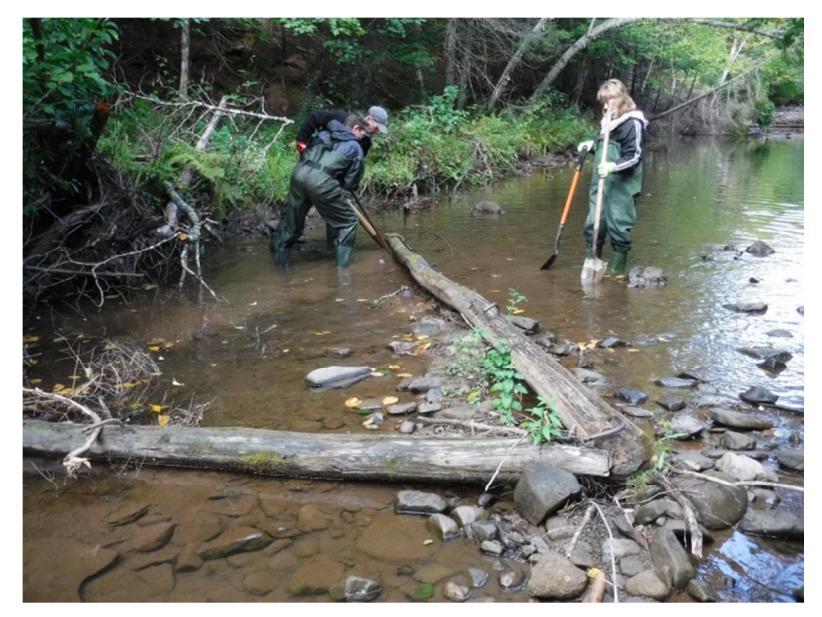
Volunteers removing the structure. Note the bank erosion and evidence of channel widening.

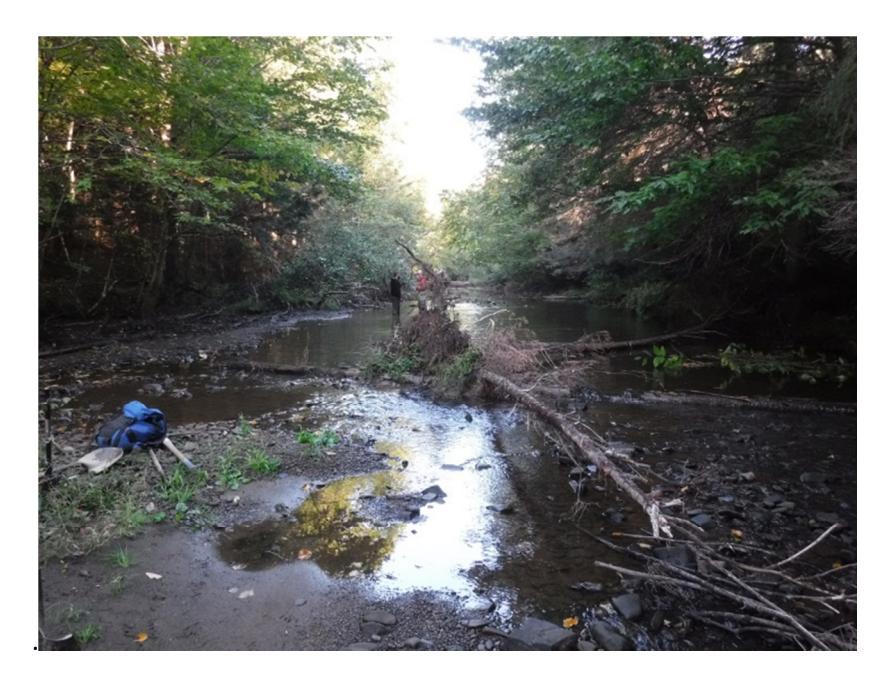
The right bank was severely eroded around the digger log. The structure was contributing to loss of floodplain/bank erosion and an over-widened channel. Approximately 3 meters of the right bank had eroded around the structure. The eroded bank material was deposited downstream and had significantly altered channel morphology and associated habitat.

View of right bank, looking upstream at the digger log. Channel had widened by approximately 3 meters.

Workers removing structure. Note the re-bar anchors and nylon webbing. Viewing downstream.
