# **Stewardship Plan to Protect and Restore the Atlantic salmon (*Salmo salar*) Habitat in the Bouctouche River**

**Prepared by: Nathalie Leblanc-Poirier,  
Rémi Donelle, Michelle Maillet, André Cormier and  
Darlene Elward**

**Presented to:  
Southeastern Anglers Association  
Environment Canada's Habitat Stewardship Program  
Fisheries and Oceans Canada and Atlantic Salmon  
Conservation Foundation**

**2013 and 2017**

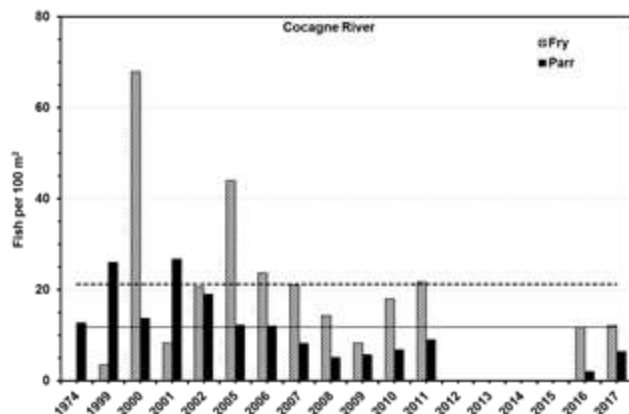
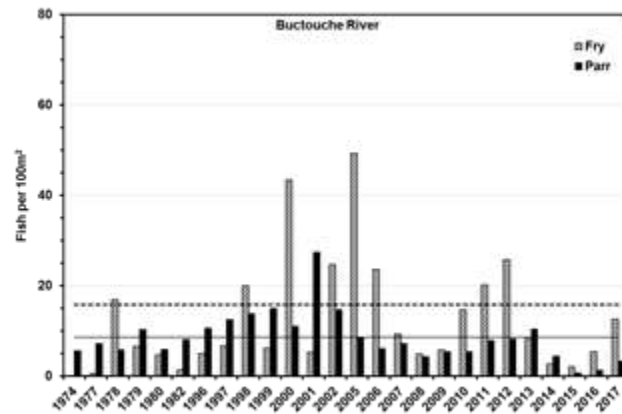
If we take a look at the past electrofishing results from both the Cocagne and Bouctouche rivers (see graphs on the right), it's easy to notice that Atlantic salmon populations have greatly decreased. They have been particularly low in the last few years. Even though they seem to be rising again (looking at Bouctouche), they are still below the desired level (dashed line for fry and full line for parr). This is why we want

Electro-fishing survey results was the following for 2017: Cocagne, 3 sites were surveyed resulting at 13 fry ( $\pm 13$  salmon/100m<sup>3</sup>) and 21 parr ( $\pm 6$  salmon/100m<sup>3</sup>); Bouctouche, 7 sites were surveyed resulting at 56 fry ( $\pm 13$  salmon/100m<sup>3</sup>) and 19 parr ( $\pm 4$  salmon/100m<sup>3</sup>). Bouctouche First Nation's data from 2015-2017 was the following: 1 salmon tagged in 2015, 0 salmon tagged in 2016, 7 salmon tagged in 2017 (8 were counted, 1 escaped).
