Association des pêcheurs récréatifs du sud-est (APRSE)/ Southeastern Anglers Association (SAA)

Cocagne, New Brunswick Report 2017

SOUTHEASTERN ANGLERS ASSOCIATION BOUCTOUCHE SALMON POOL RESTORATION

BOUCTOUCHE SALMON POOL RESTORATION

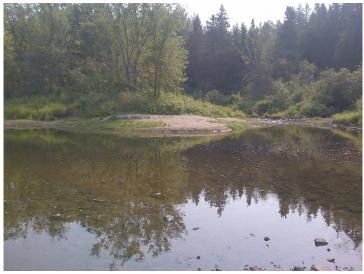
Facing South Branch – at the Pool

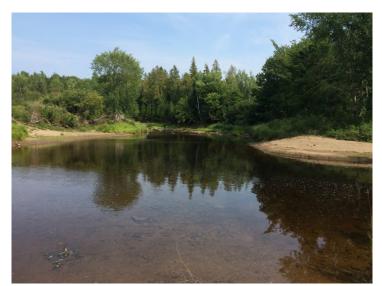
Facing Main Branch – at the Pool

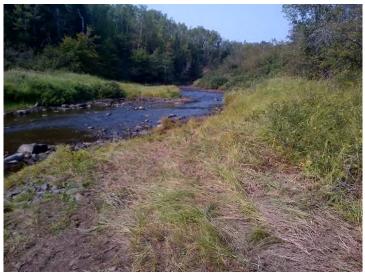
Upstream from Pool on Main Branch

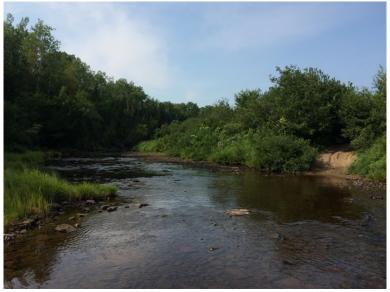
Upstream from Pool on Main Branch

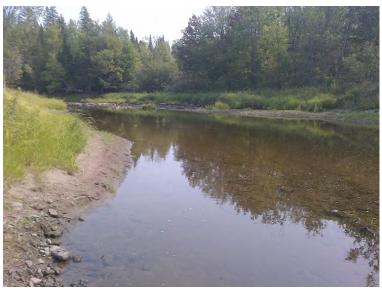
Downstream from Pool on Main Branch

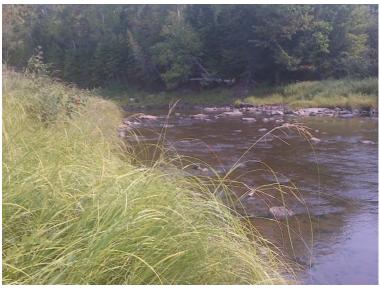
Downstream from Pool on Main Branch

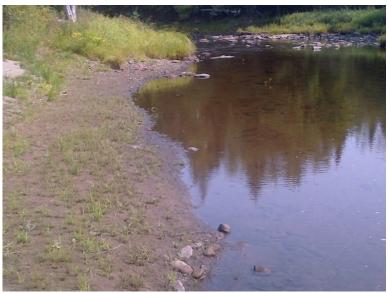
Downstream from Pool on Main Branch - Sedimentation

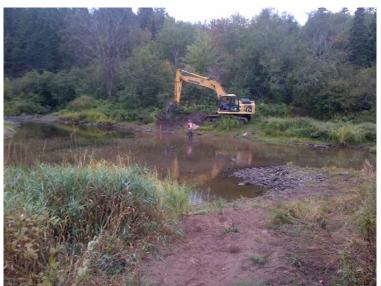
Construction of Rock Spur (Deflector)

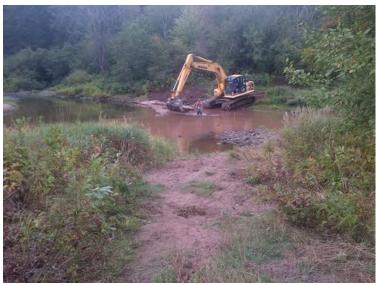
Construction of Rock Spur (Deflector)

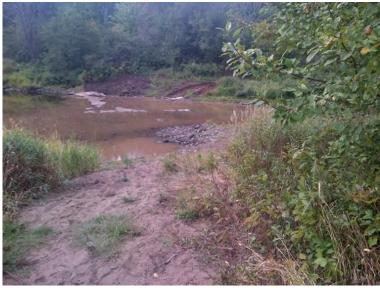
Construction of Rock Spur (Deflector)

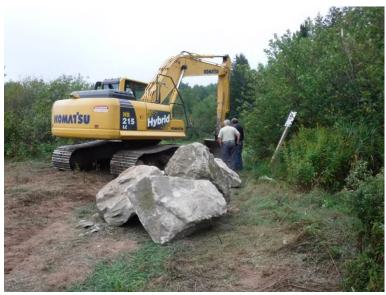
Construction of Access Stabilization

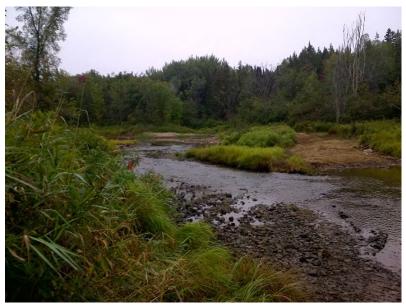
Upstream of Pool - Blocked Access to Crossing

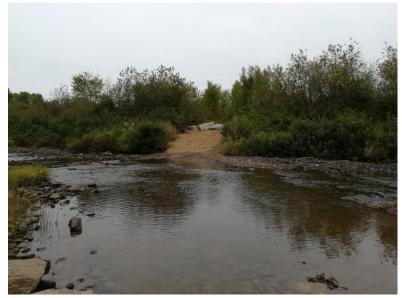
Upstream of Pool - Blocked Access to Crossing

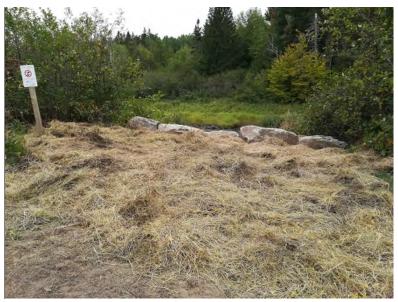
Upstream of Pool – Access Blocked

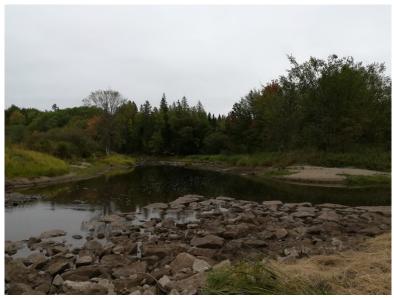
At the Pool – Rock Spur Facing Main Branch

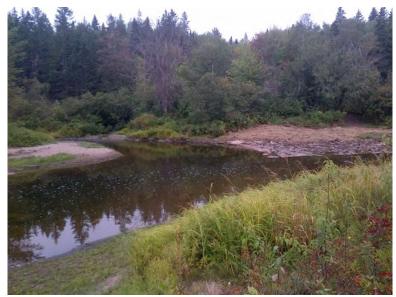
At the Pool – Rock Spur Facing South Branch

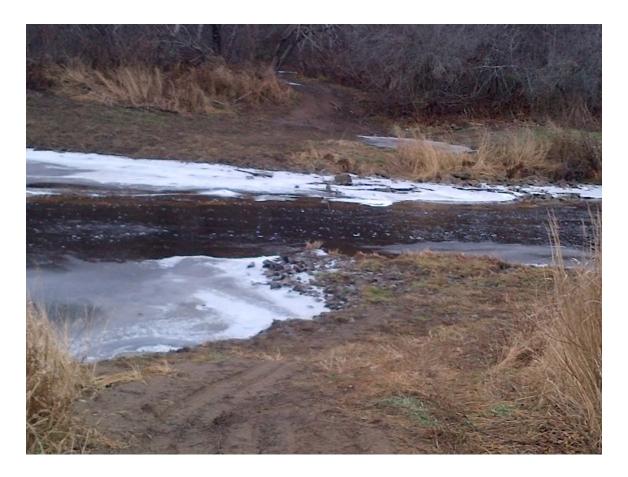
WATER LEVEL HAS RISEN ½ m ABOVE DEFLECTOR

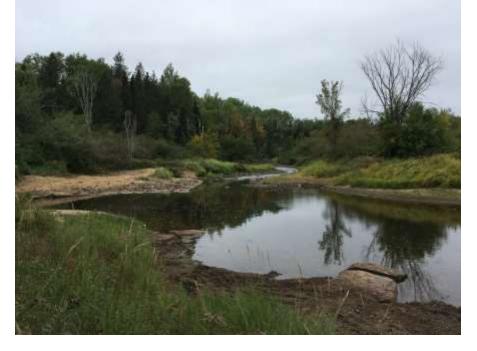
1. Viewing upstream- showing two rock spurs (foreground) and rock deflector on opposite bank (left).

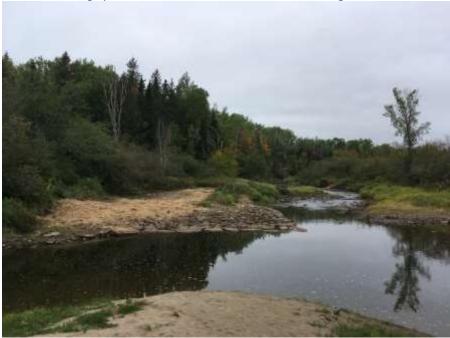
2. Viewing upstream toward north branch river. Showing rock deflector.

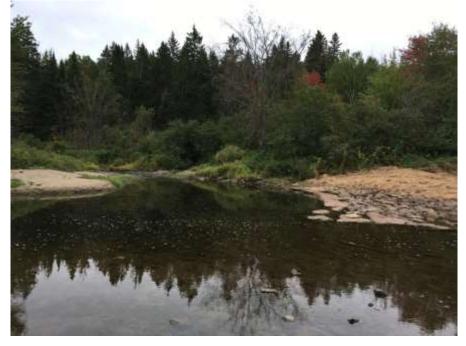
Viewing upstream toward South Branch river. Rock deflector shown on right. 3.

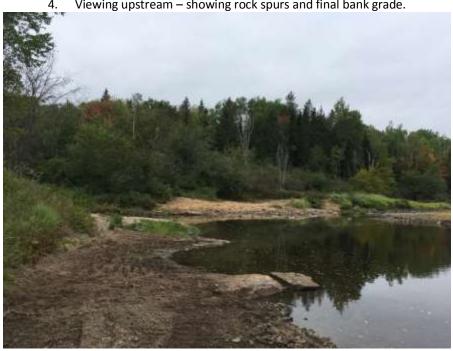
Viewing upstream – showing rock spurs and final bank grade. 4.

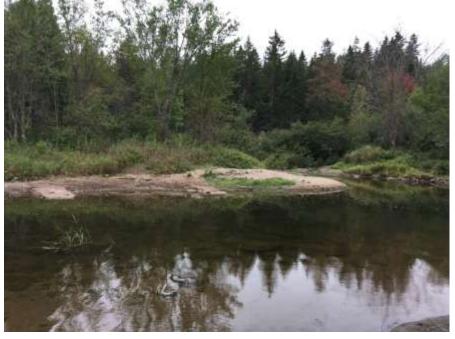
5. Viewing south from north bank – at confluence pool. Rock spurs on opposite bank.

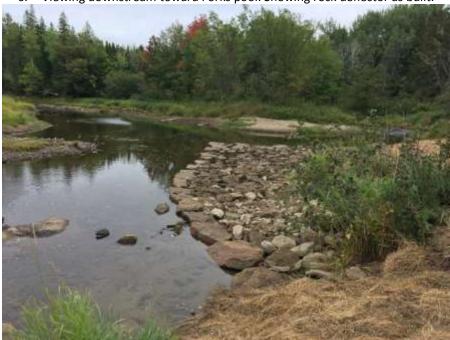
6. Viewing downstream toward Forks pool. Showing rock deflector as built.

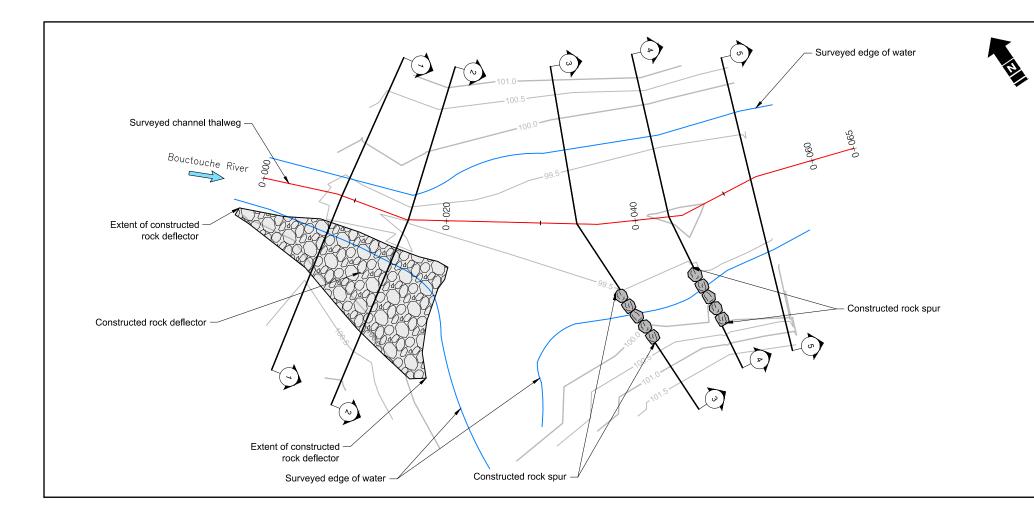
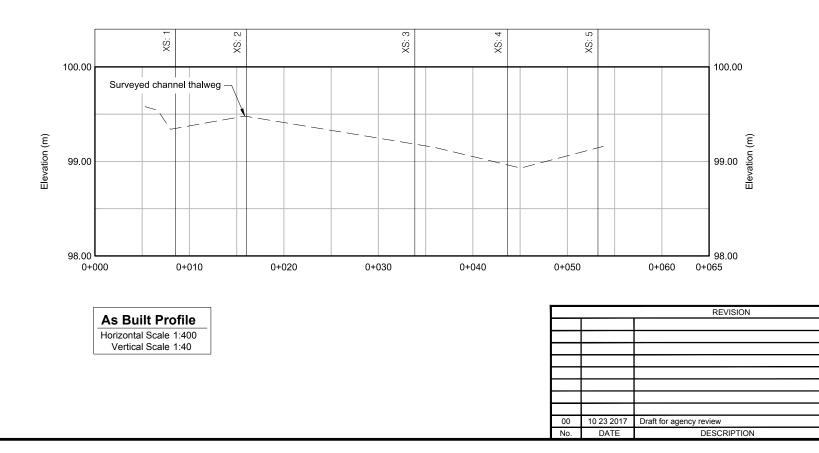
- 1. Survey completed by Matrix Solutions Inc. on September 27, 2017.
- All elevations displayed are relative.
 Contours are shown in 0.5m intervals.
