Southeastern Anglers Association Inc.

Subject: Mill Creek – 2017 Summary of Instream Work Completed by Southeastern Anglers Association

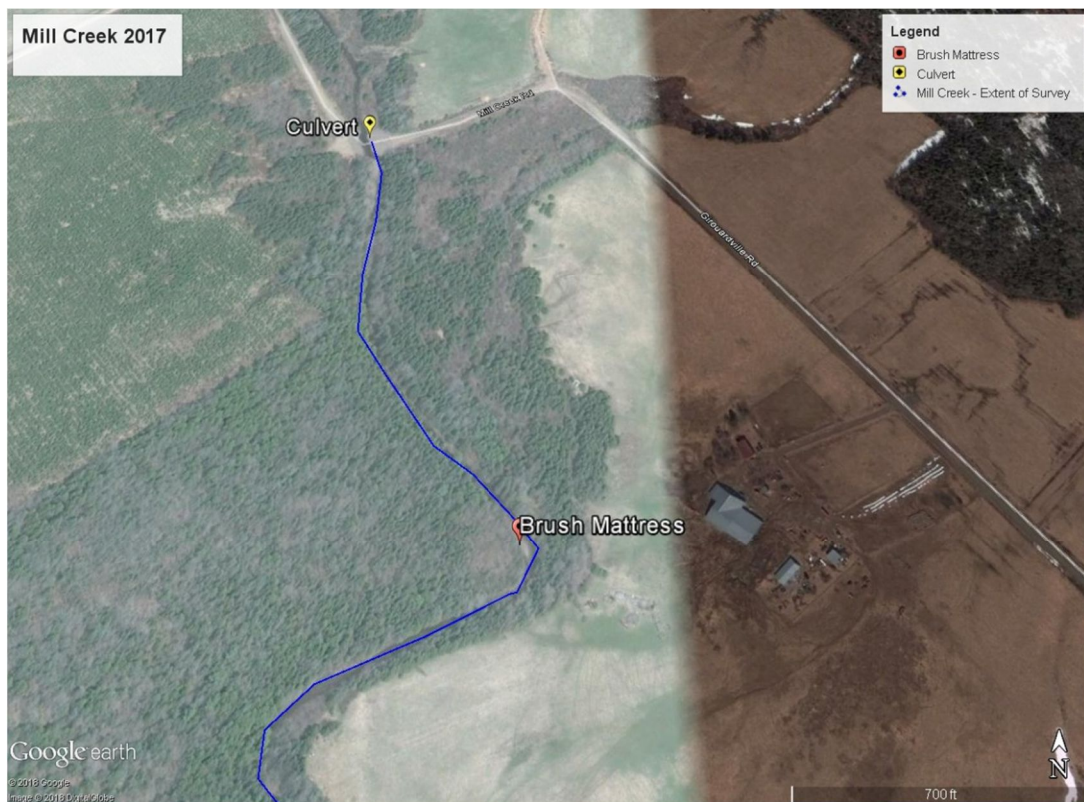
A digger-log, located approximately 10m upstream of the site, caused bank erosion and significant widening of the channel and erosion of floodplain habitat. This digger-log was removed during the September 2016 restoration work. The brush mattress was installed by SAA to prevent further erosion and channel widening from occurring.

Figure 1 Location of Brush-Matting treatment along Mill Creek, UTM Zone 20T E 359499 N 5145620.

On September 28, 2017 the SAA installed 35m of brush mattress along an eroded bank located on the inside bend of Mill Creek. A failed digger log, located upstream from the site, resulted in bank erosion, loss of floodplain habitat, and an over-widened channel. The installation of the brush mattress was completed with use of hand-tools and manual labor only, no machinery was used. No disturbance to the streambed or bank occurred during installation. Brush material was sourced approximately 100m away from top of bank. When possible, damaged or dead trees/branches were used and were collected from multiple areas to minimize the concentration of disturbance. Brush materials were anchored to existing stumps/trees with biodegradable twine. The brush mattress treatment covered an area of approximately 140m² (35m length x 4m width). Brush mattress was installed at UTM Zone 20T E 359499 N 5145620.
